SEISMIC PERFORMANCE  
OF  
WEDGE WALL  
PANEL CONNECTION SYSTEMS

*Ali Sahin Tasligedik*  
*Assoc. Prof. Stefano Pampanin*

UNIVERSITY OF CANTERBURY  
CIVIL AND NATURAL RESOURCES ENGINEERING DEPARTMENT

July 2013

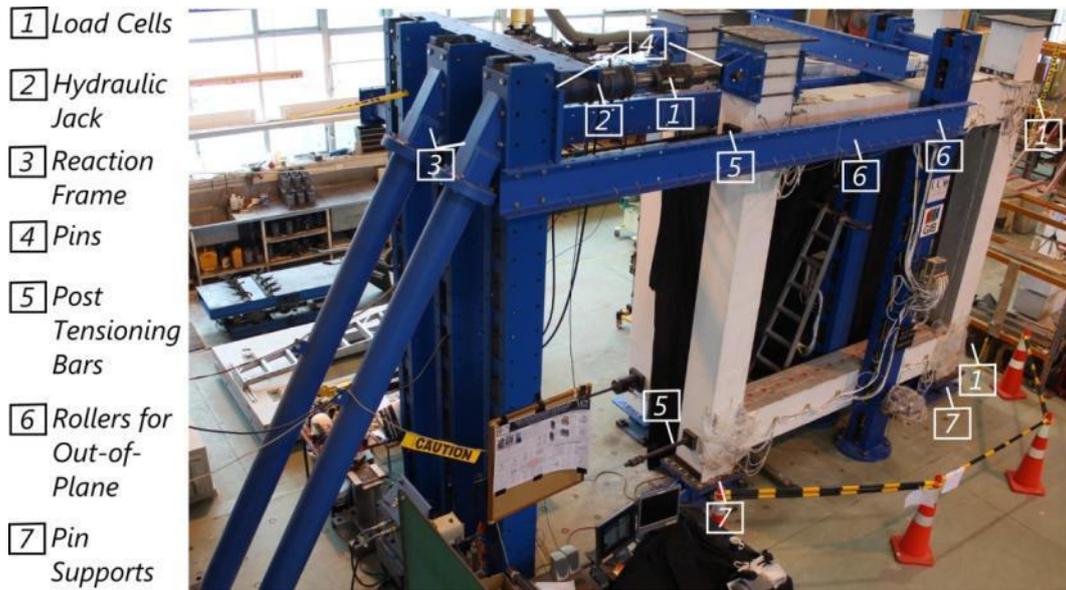
Figure 2.1b)

| Hydraulic jack capacity | : 1000 kN |
| Reaction frame allowable load | : 500 kN |
| Post tensioning bars | : 40 mm Macalloy 1030 |
| Load cell capacity (Connected to hydraulic jack) | : 1000 kN |
| Post tensioning load cell capacity | : 700 kN |

Figure 2.1. a) Schematics of the test setup, b) Photographic view of the test setup

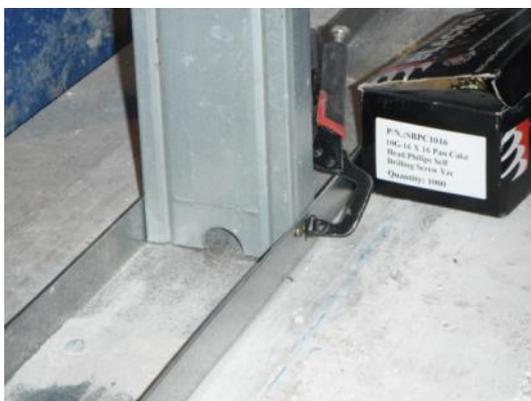
Figure 3.1a)

In order to simulate standard construction practice, the Wedge panel connection systems were installed on a typical partition wall skeleton, consisting of a light gauge steel studded drywall partition. Therefore, steel studs, tracks and gypsum wallboards (Figure 3.1a, Figure 3.1b) were required for the construction of the drywall. Overall, the Wedge panel connection system consist of the wedge panel connectors and the architectural/finishing wall panels (Figure 3.1c, Figure 3.1d).

**Figure 3.1.** a) Steel studs and tracks of 90 mm height, b) Standard gypsum plasterboard, c) Aluminium Wedge panel connectors, d) Timber panels

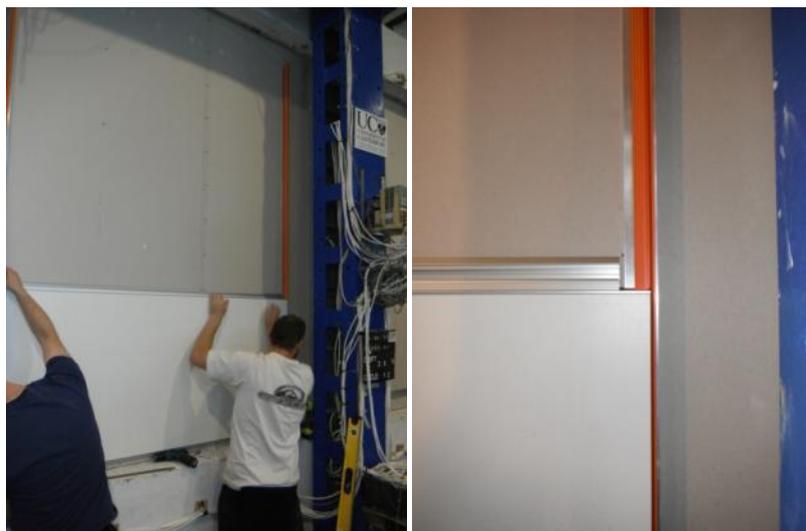
The specimen WEDGE02 (Seismic) had same basic type of connections with two different construction details. The lowest horizontal aluminium member was made of two separate pieces located under each respective panel. Moreover, plastic jointing elements were used in between the vertical gaps to provide a bumper effect. The rest of the installation procedure is the same as per the standard WEDGE 01 system

**Figure 4.4.** WEDGE 02 Specimen. Plastic vertical jointing elements located in the vertical gaps.
